UNDERWATER BRIDGE INSPECTION REPORT

STRUCTURE NO. 92052

CSAH NO. 19

NORTH FORK CROW RIVER

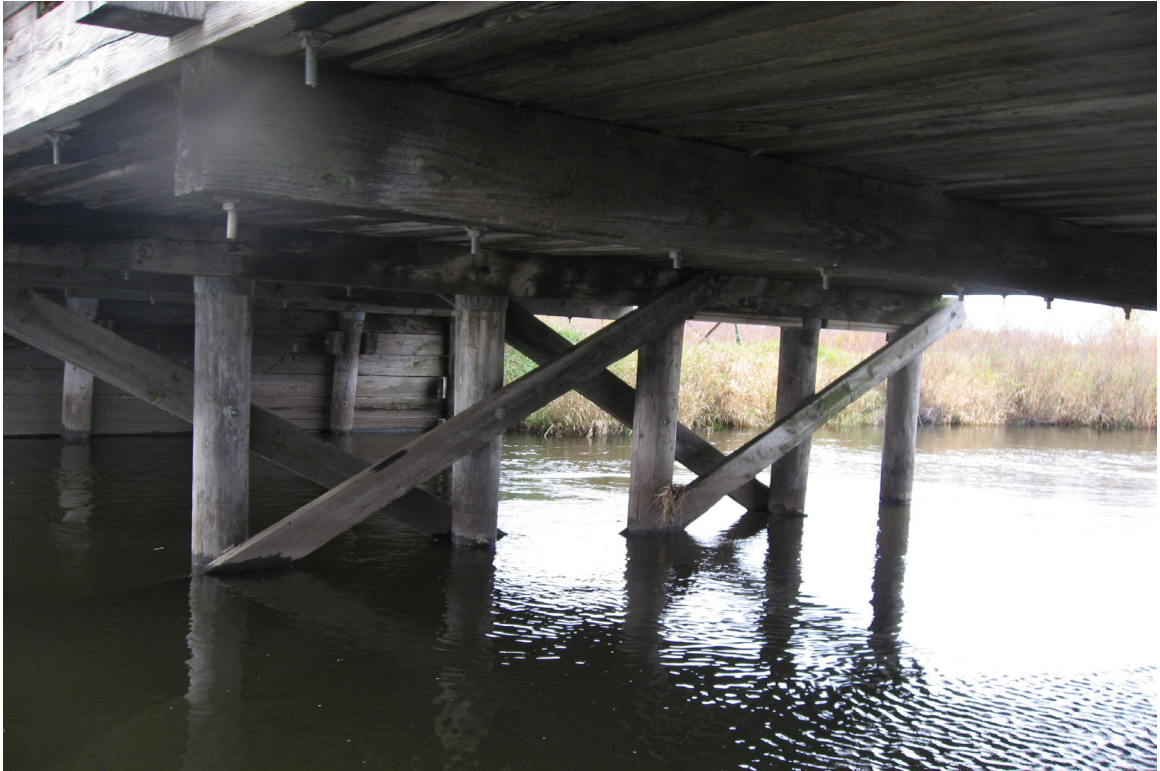
Photograph 1. View of Pier 1, Looking Northwest.

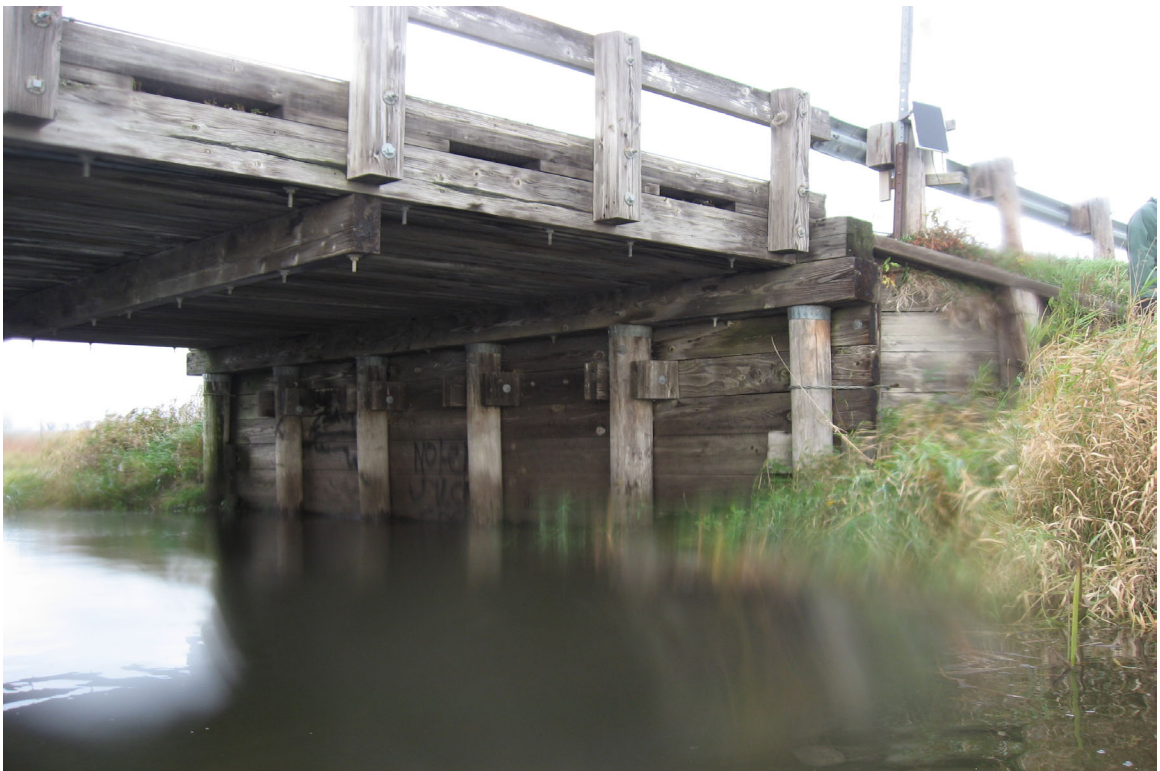
Photograph 2. Overall View of East Abutment, Looking Northeast.

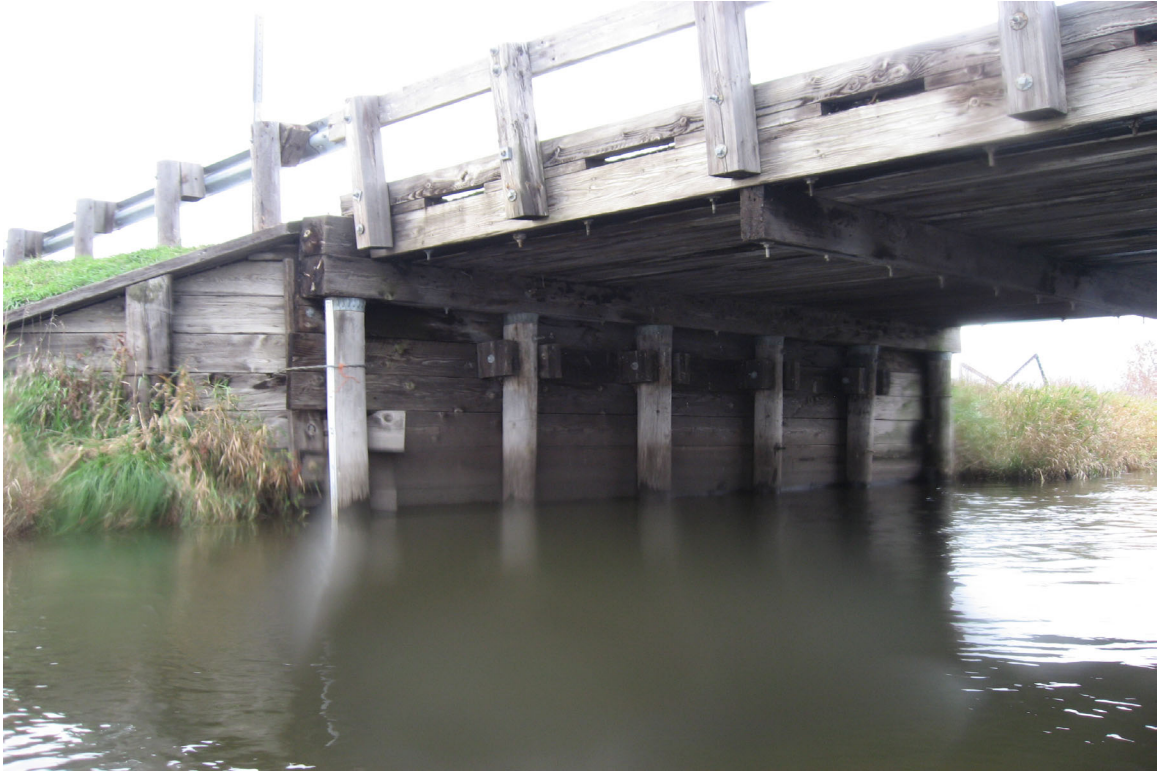
Photograph 3. Overall View of West Abutment, Looking Northwest.

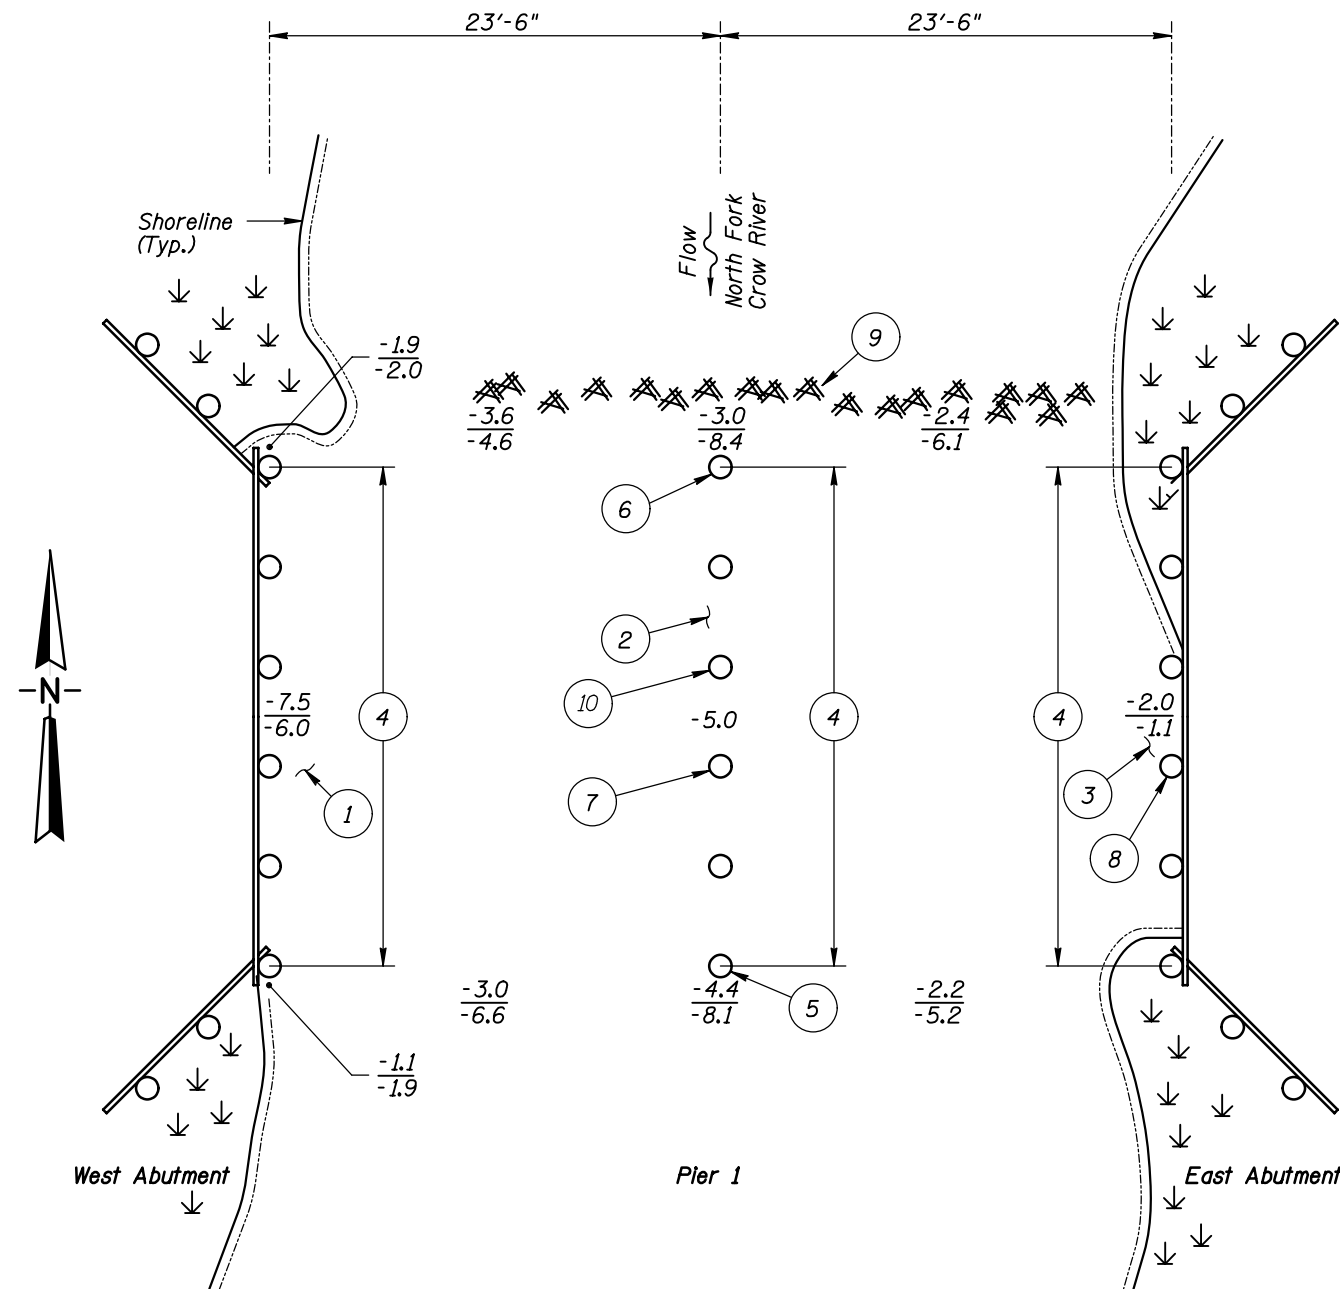
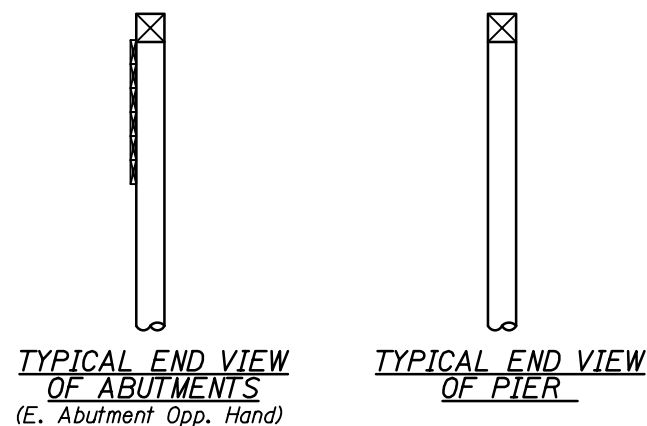
SOUNDING PLAN

- 1 The channel bottom at the West Abutment consisted of cobbles 1 foot in diameter and smaller and silt with up to 6 inches of probe rod penetration. At the middle of the abutment, the channel bottom consisted of firmer sand.

- 2 The channel bottom at Pier 1 consisted of silty sand with up to 1 foot of probe rod penetration.
- 3 The channel bottom at the East Abutment consisted of cobbles and silt with up to 1 foot of probe rod penetration and riprap 1 foot in diameter and smaller.

- 4 All timber piles exhibited approximately 5 percent section loss near the waterline with up to 1/8 inch wide vertical outer shell cracking extending the full height of the piles with penetrations up to 1/4 inch deep near the waterline.

- 5 The diagonal brace was broken/split below the waterline and was no longer engaged to the downstream pile at the pier. Overall, split was 5 to 6 feet long. The bracing was missing 50 percent of the member on the last 2 feet of the bracing.

- 6 The diagonal brace was broken below the waterline and was no longer engaged to the upstream pile at the pier. The bracing was missing 75 percent of the member on the last 3 feet of the bracing.

- 7 The diagonal brace was broken below the waterline and was no longer engaged to the pile at the pier. The bracing was missing 90 percent of the member on the last 3 feet of the bracing.

- 8 The timber pile exhibited decay, delamination, and outer shell cracking from the waterline to the channel bottom with up to 2 inches of penetration.

- 9 A moderate accumulation of timber debris, including 2 foot diameter logs, was observed along the entire upstream fascia below the water.
- 10 The diagonal brace exhibited several 1/2 inch wide splits with one of them going through the connection.

Replace the broken and/or split diagonal braces during future maintenance operations.
Monitor the decayed pile at the East Abutment during future inspections, and if found to be progressing, remedial measures may then be warranted.

Monitor the accumulation of timber debris at the bridge, and if found to be progressing, removal operations may be warranted at that time.
